HISTORIC STRUCTURE REPORT

ST. PHILOMENA CATHOLIC CHURCH

KALAUPAPA NATIONAL HISTORICAL PARK
Molokai, Hawaii

January 1985

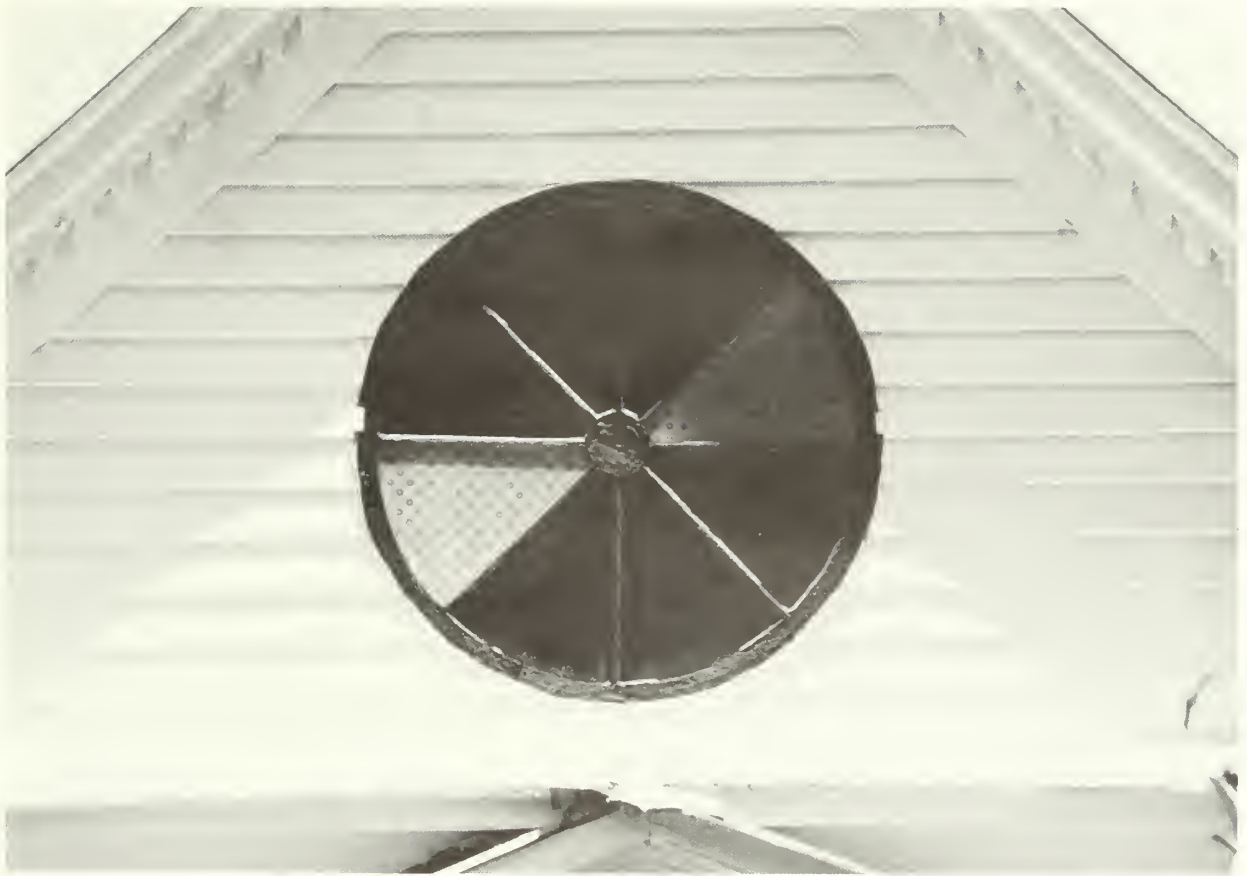
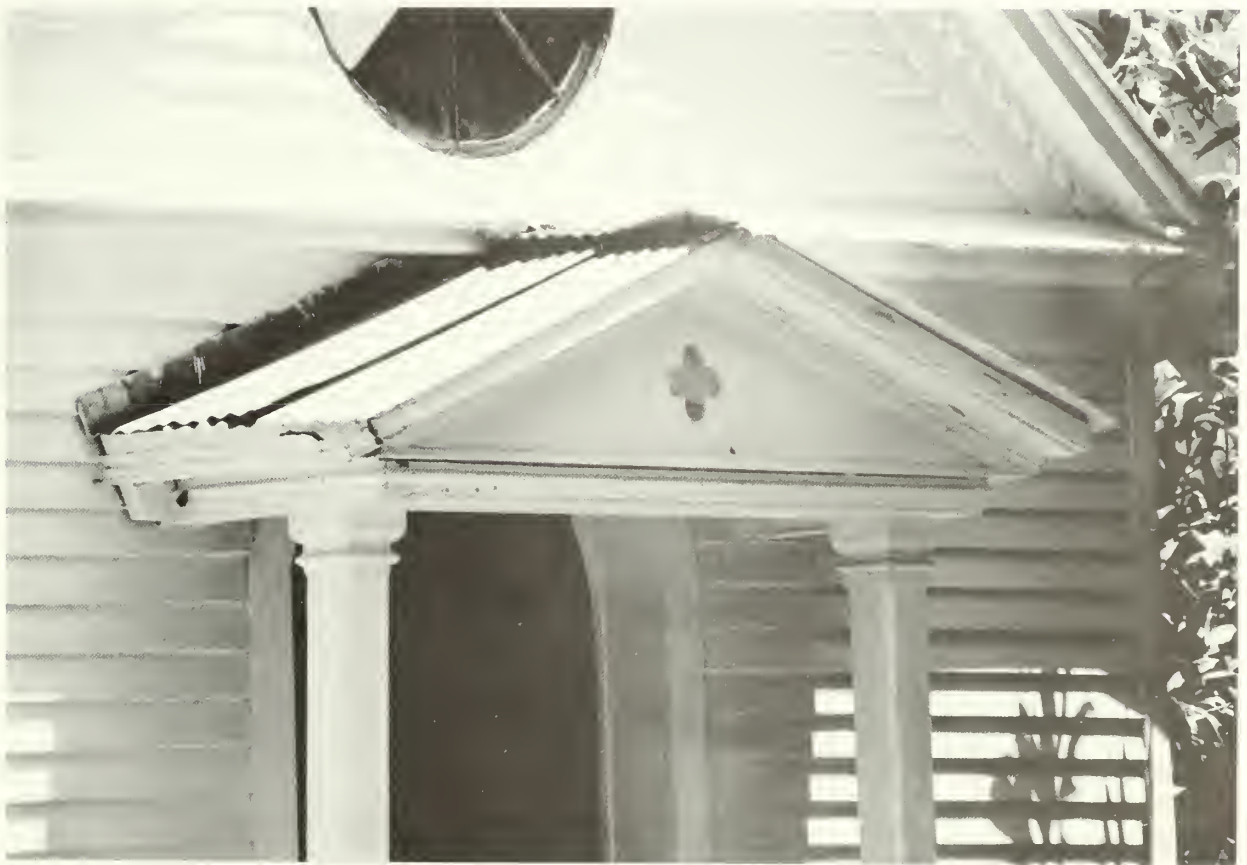
Illustration A14.

Detail of portico roof at 'west' entry of 1876 nave. Deterioration of the framing and sheathing no longer will hold the roofing nails. 6/84. R.L.C.

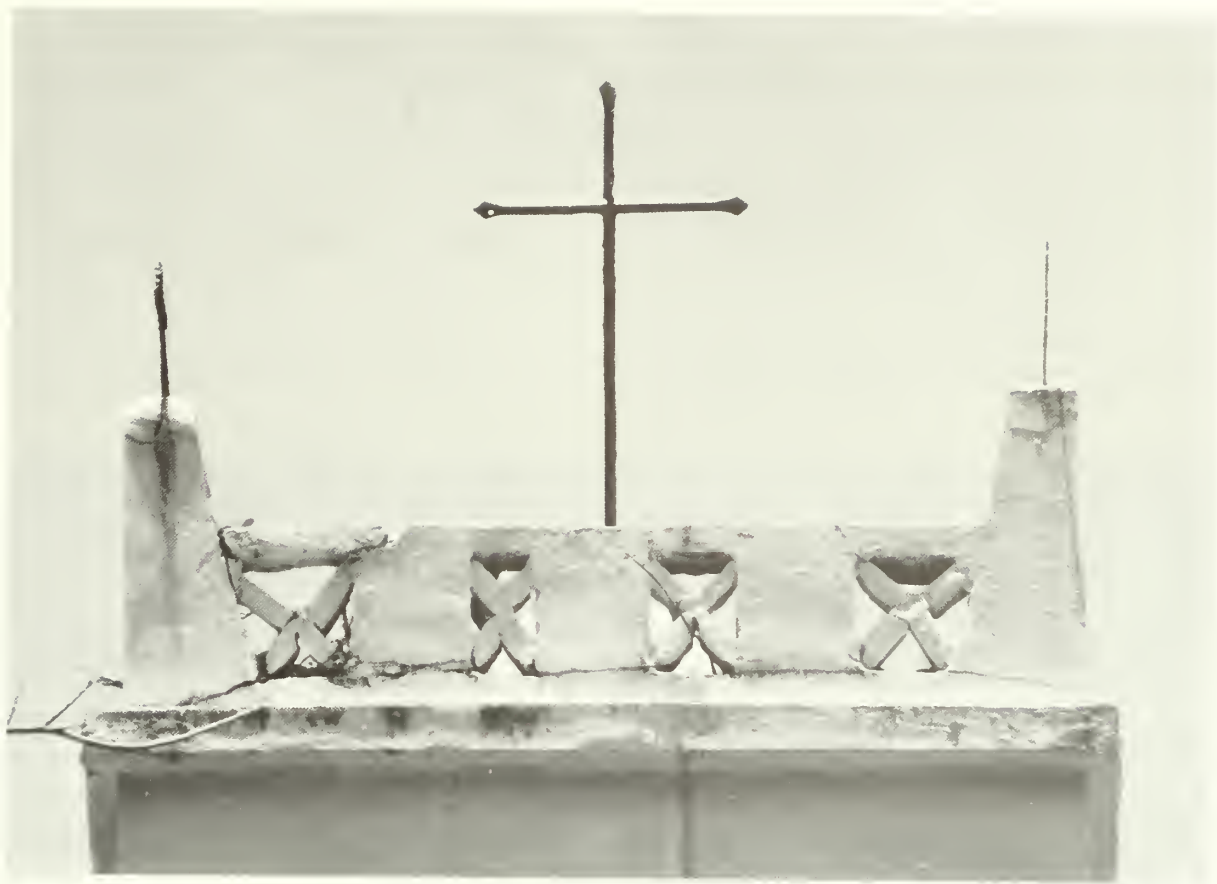
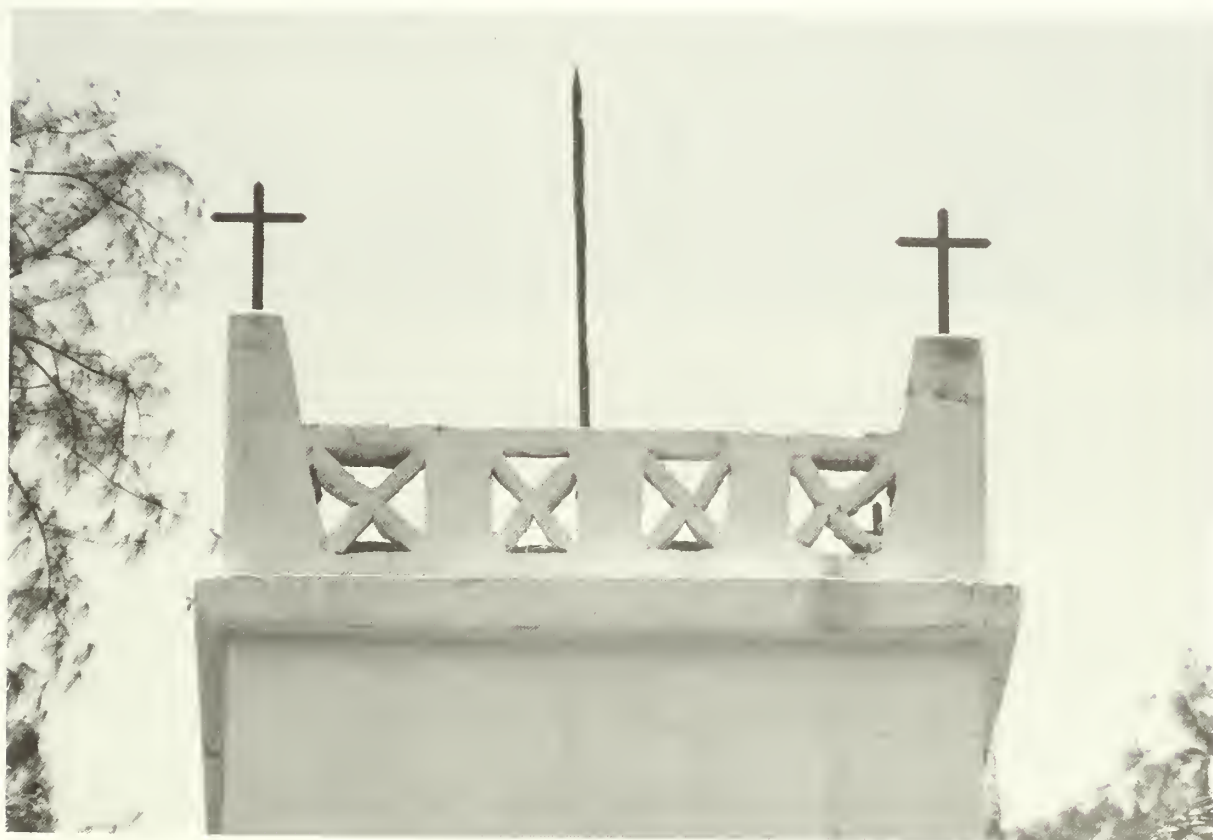
Illustration A24.

'North' and 'west' parapets of bell tower. Note repair caps on pinnacles resulting from replacement of crosses. 6/84. R.L.C.

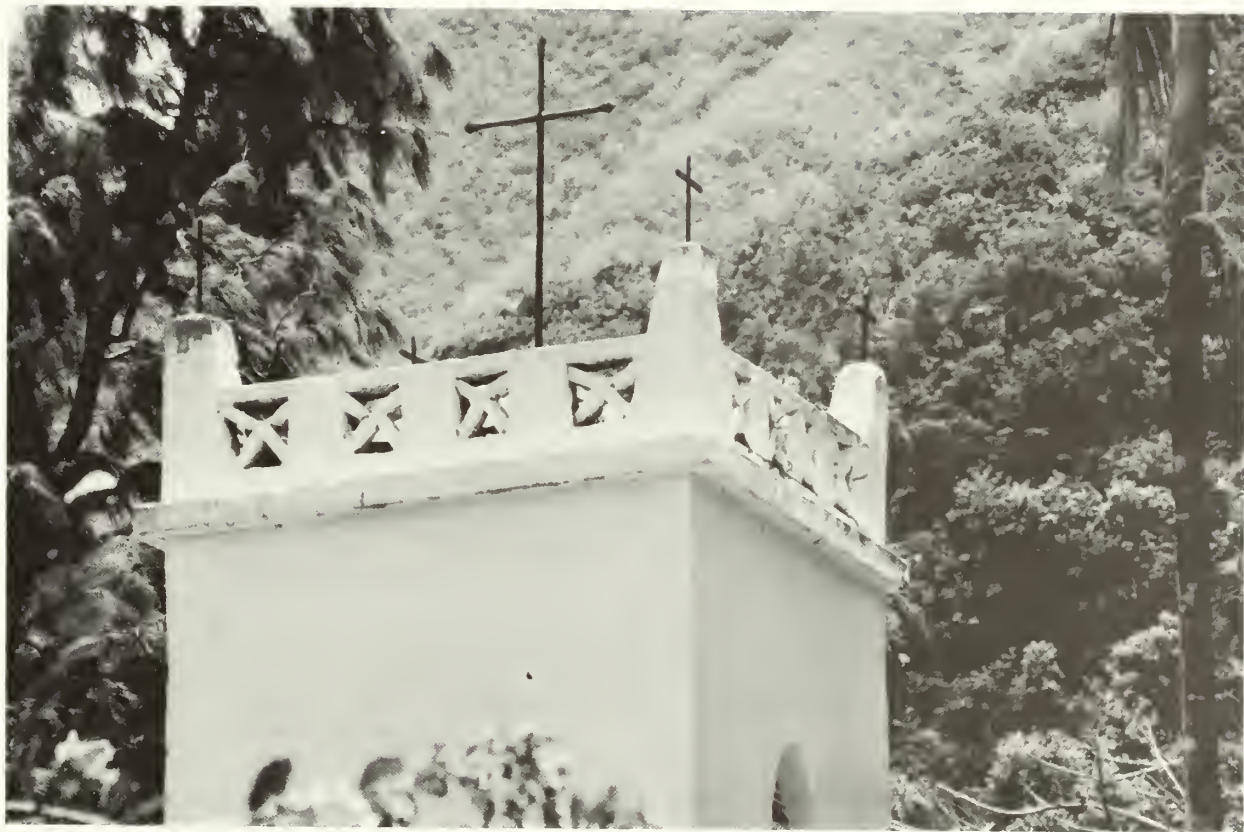
Illustration A25.

View of parapet of 'west' elevation of bell tower. Note base crack here also. The 'southwest' pinnacle is not secure. 6/84. R.L.C.

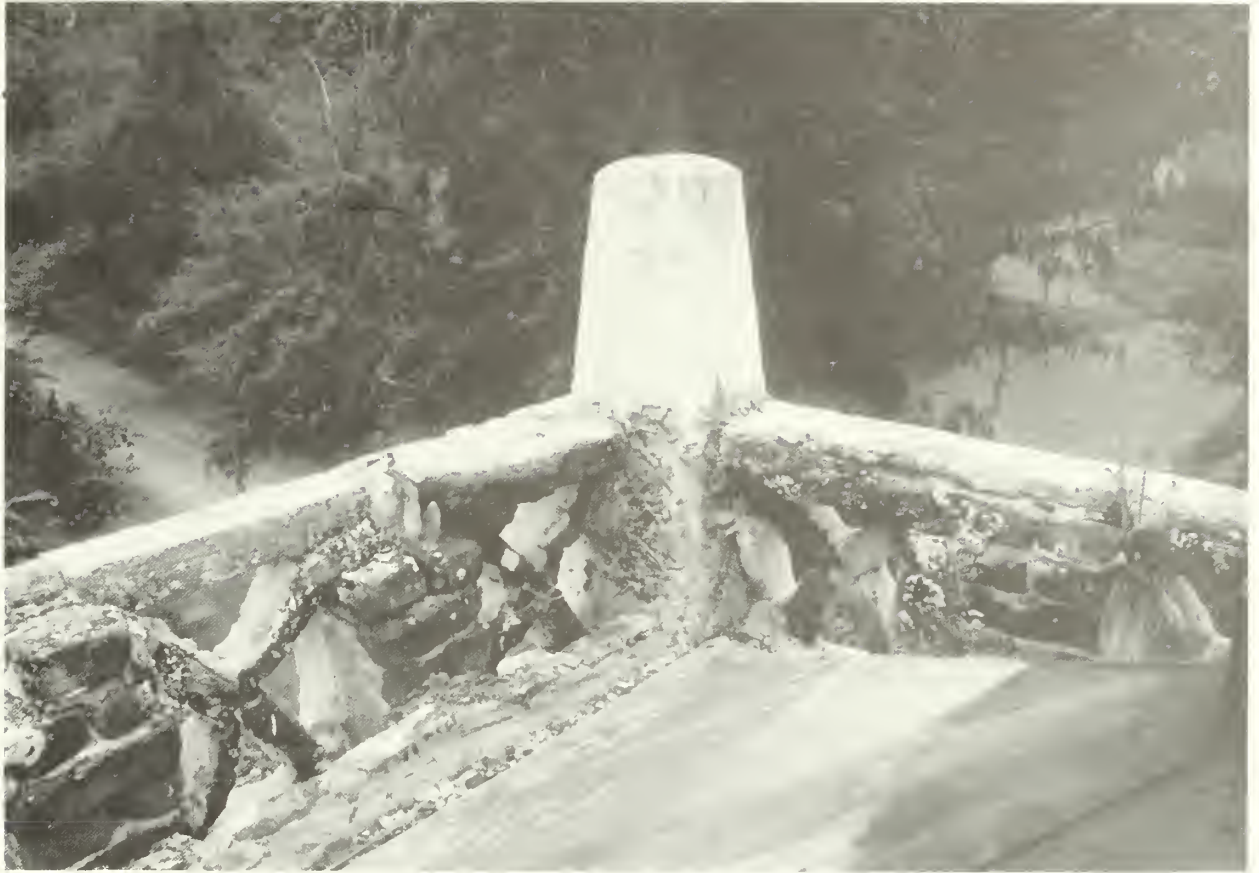
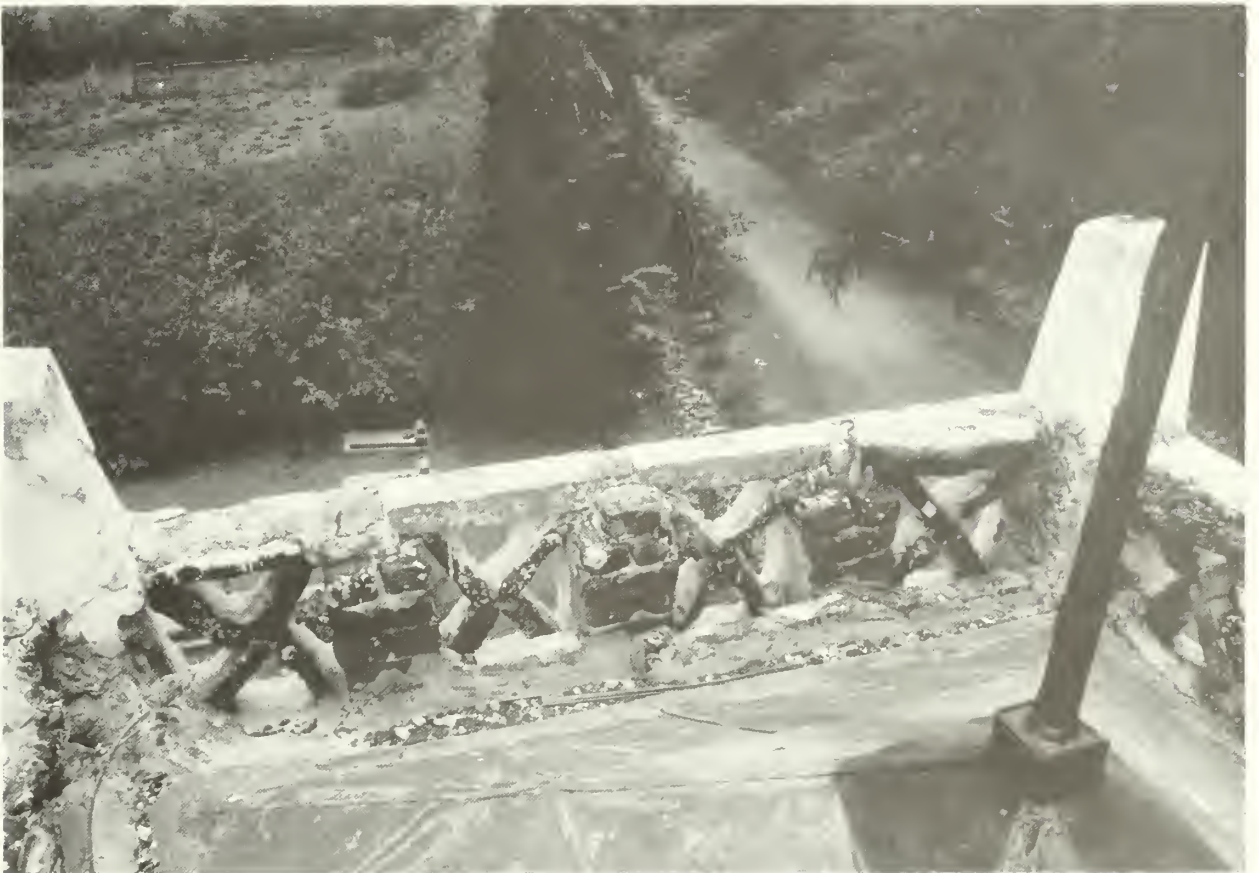
Illustration A29.

'East' parapet. Note concrete masonry units used for repairs. The copper roofing is in reasonably good condition but the drainage gutter around the base of this square pyramidal roof does not drain well and the base plate of the roof framing is rotted. All crosses are rusted and exfoliated. 5/84. H.G.L.

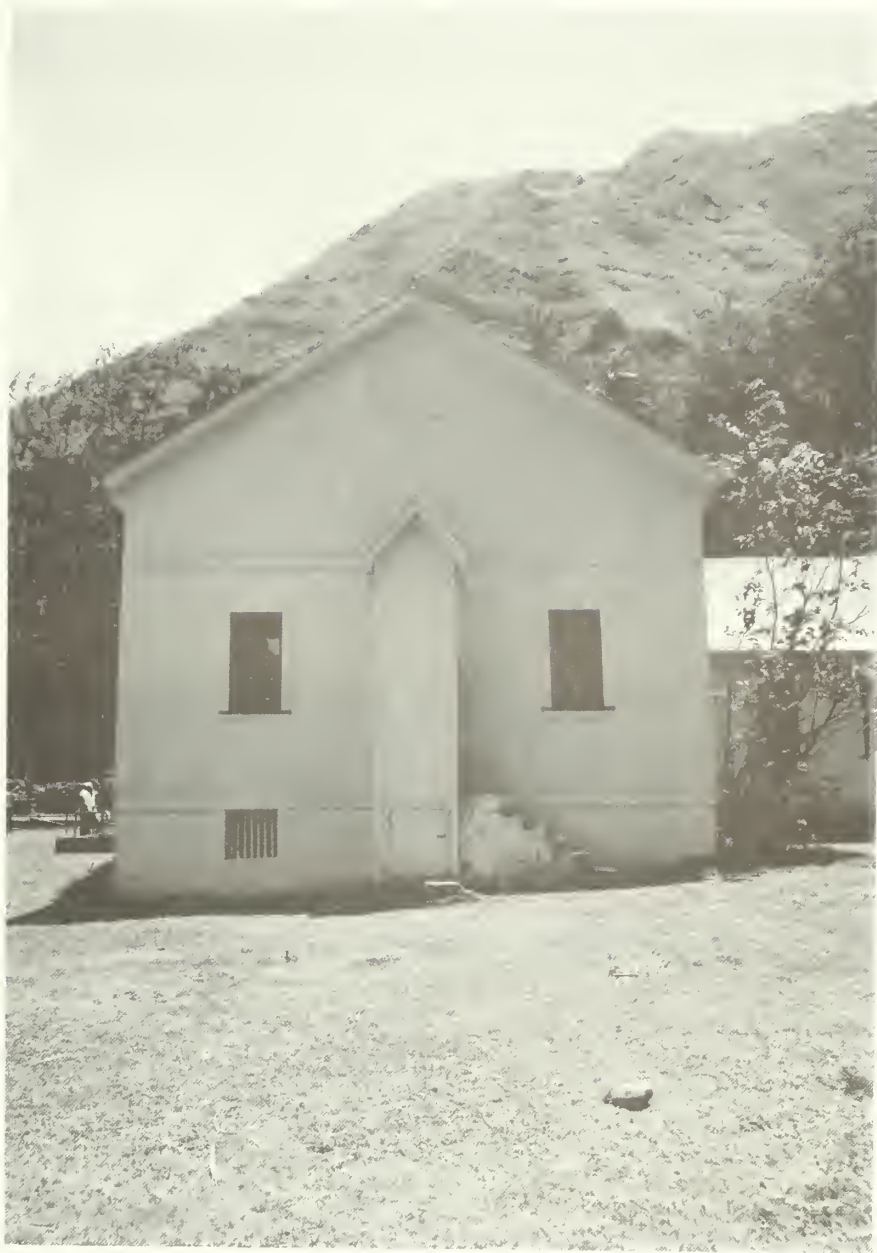
Illustration A33.

Rear ('north') elevation of 1888-89 portion of building. This wall was replaced after collapse during a storm. The sand density in the paint on this wall does not match that of the other siding of the building. 6/84. R.L.C.

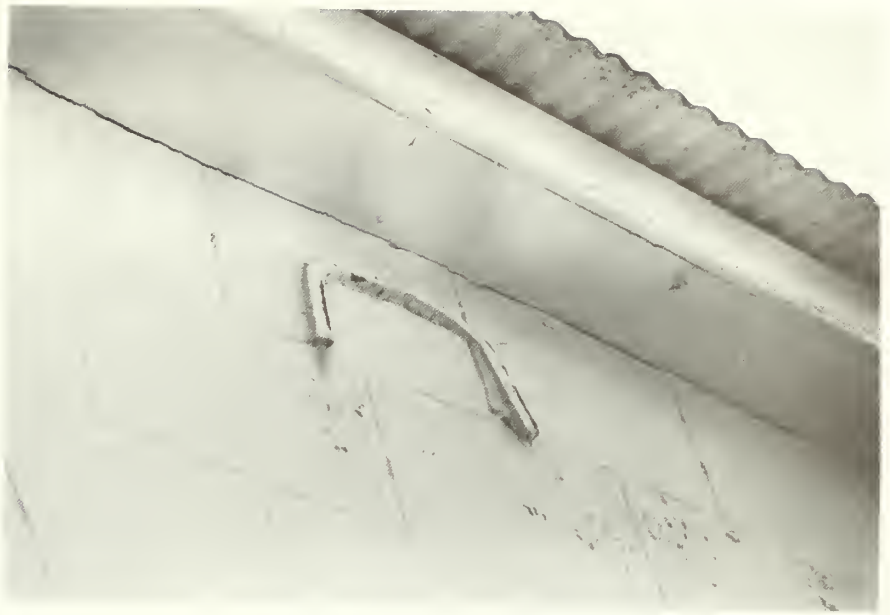
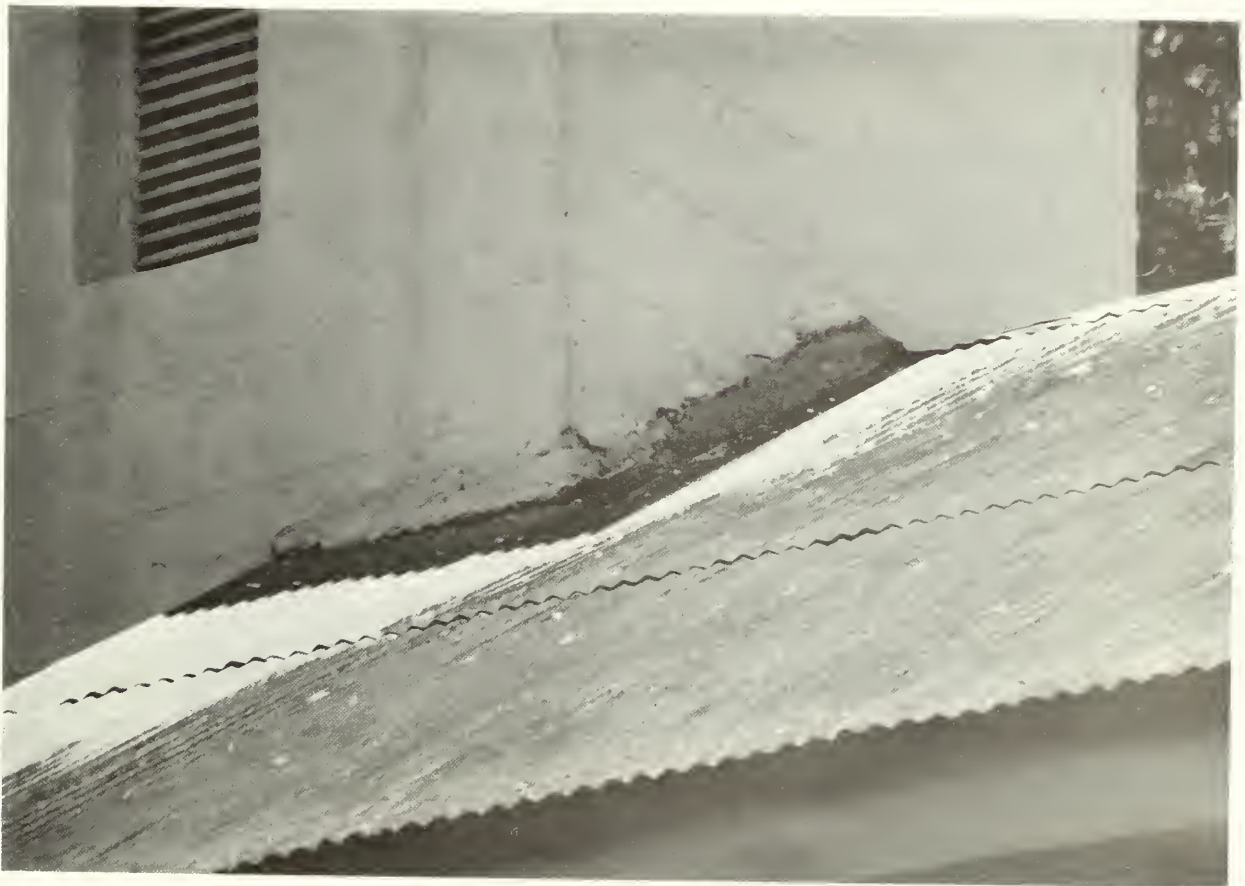
Illustrations A39 and A40.

Detail at juncture of main roof and bell tower. Numerous attempts to seal this joint are evident. Leakage here is the cause of damage to the stations of the cross. 6/84. R.L.C.

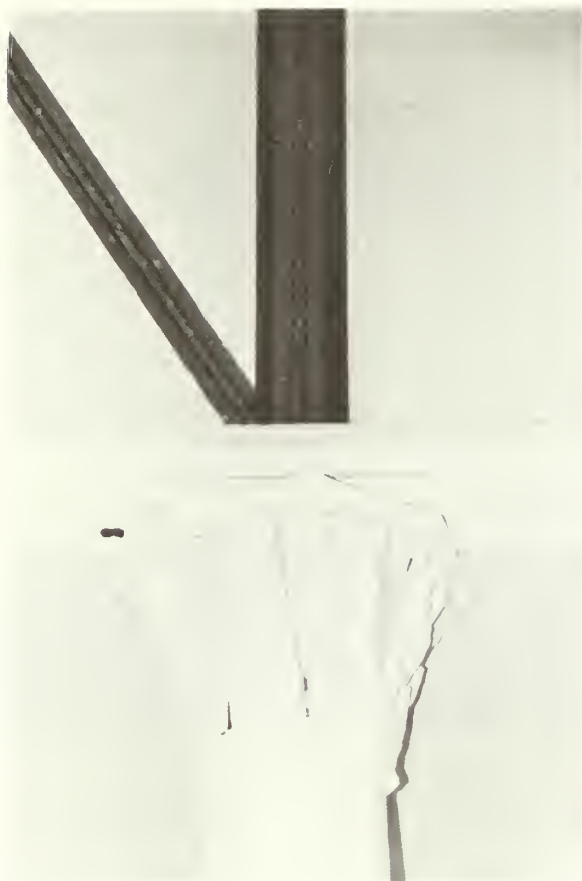
Illustrations A50 and A51.

Base of 'southeast' column of 1888 nave showing subsidence of floor structure, which damaged base trim. 8/84. P.C.C.

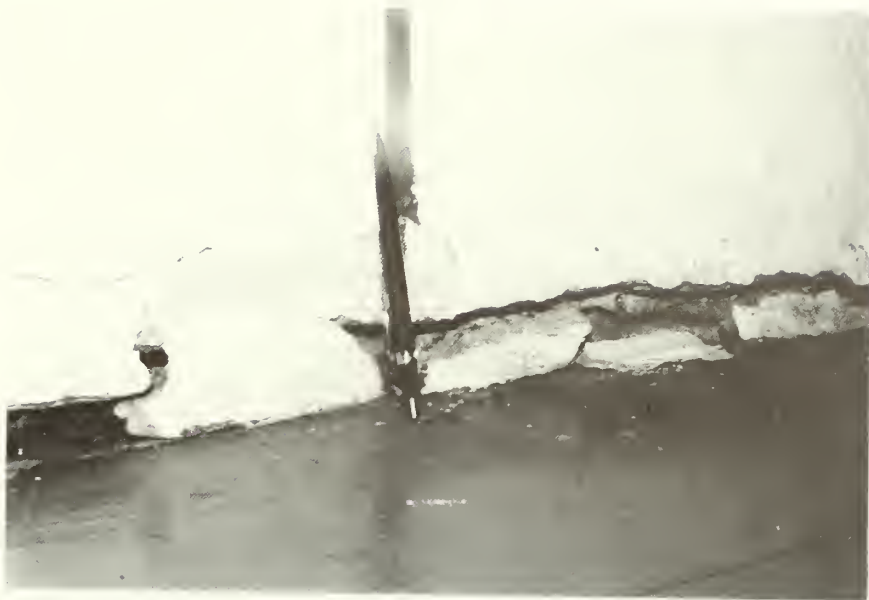
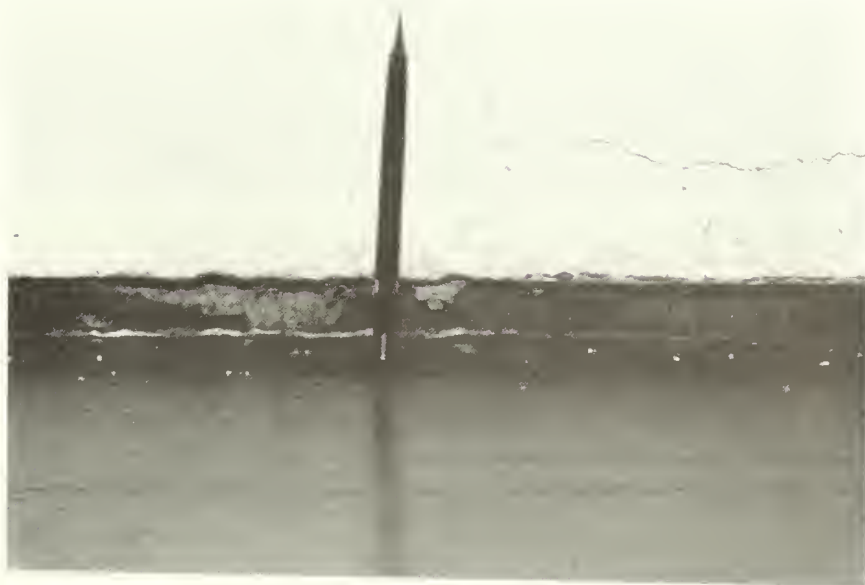
Details showing subsidence of floor of 1888 nave. The greatest settlement occurred in the area of the two 'southern-most' columns. Repairs to the wall plaster have failed as the cement plaster mix did not bond to the earlier lime plaster. 8/84. P.C.C.

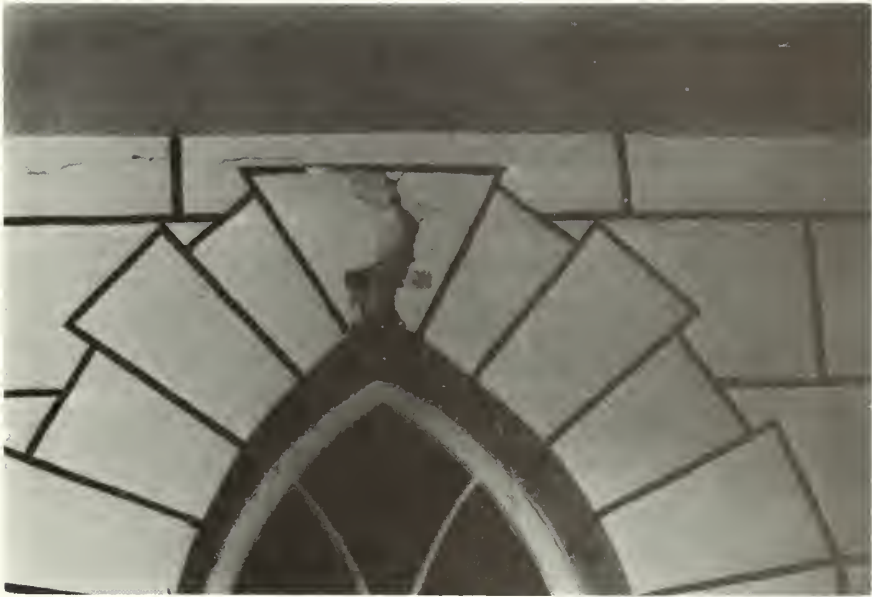
Illustration A52. Earthquake damage at 'south' window of 1888 nave, west wall. Similar damage occurred at the window on the opposite side of the building. There has been no movement recorded since the tell-tale was installed. 8/84. P.C.C.

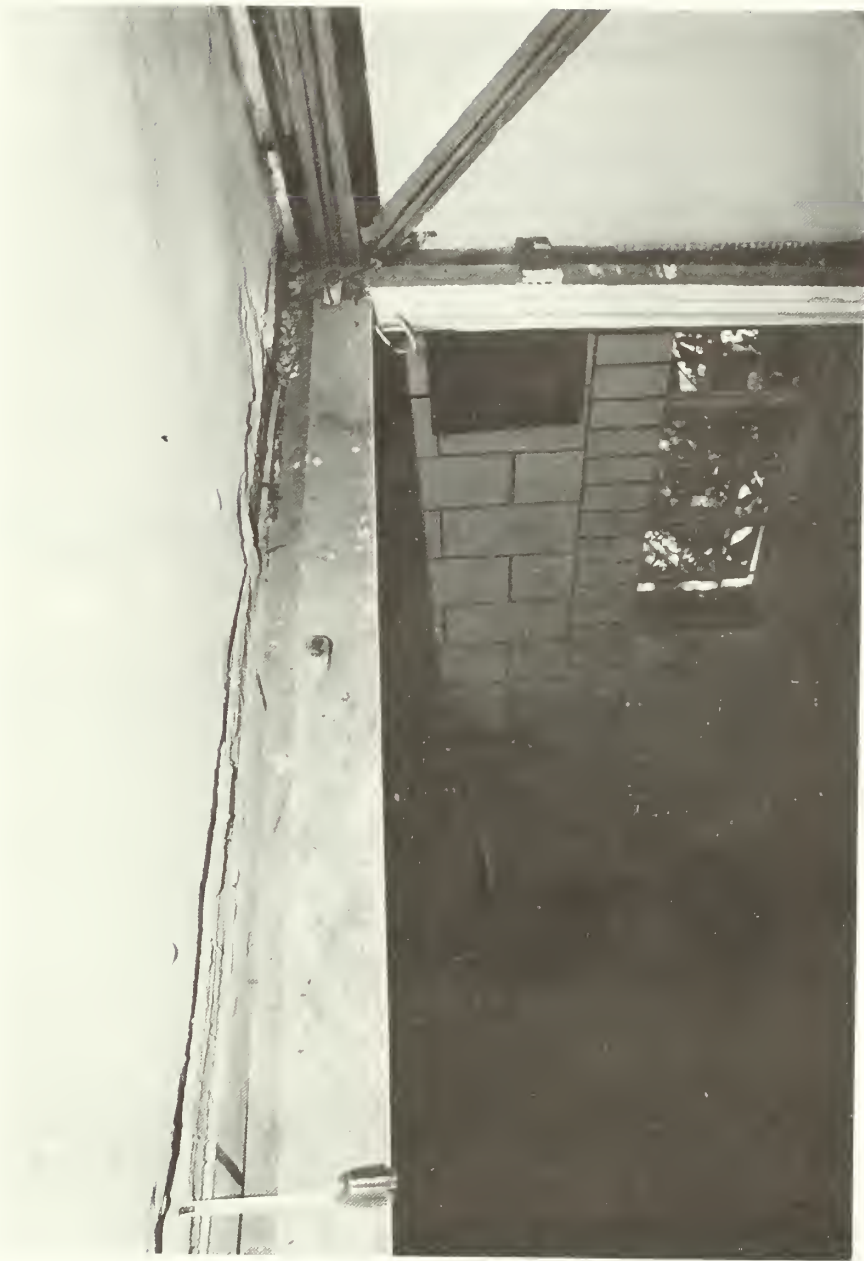
Illustration A53.

Top of cornice at 'south' wall of 1888 nave. The nails which formerly secured it to the wood nailer set in the masonry wall are completely rusted away, and it is held in place only by the ends of the cornice members at the base of the vault. 8/84. P.C.C.

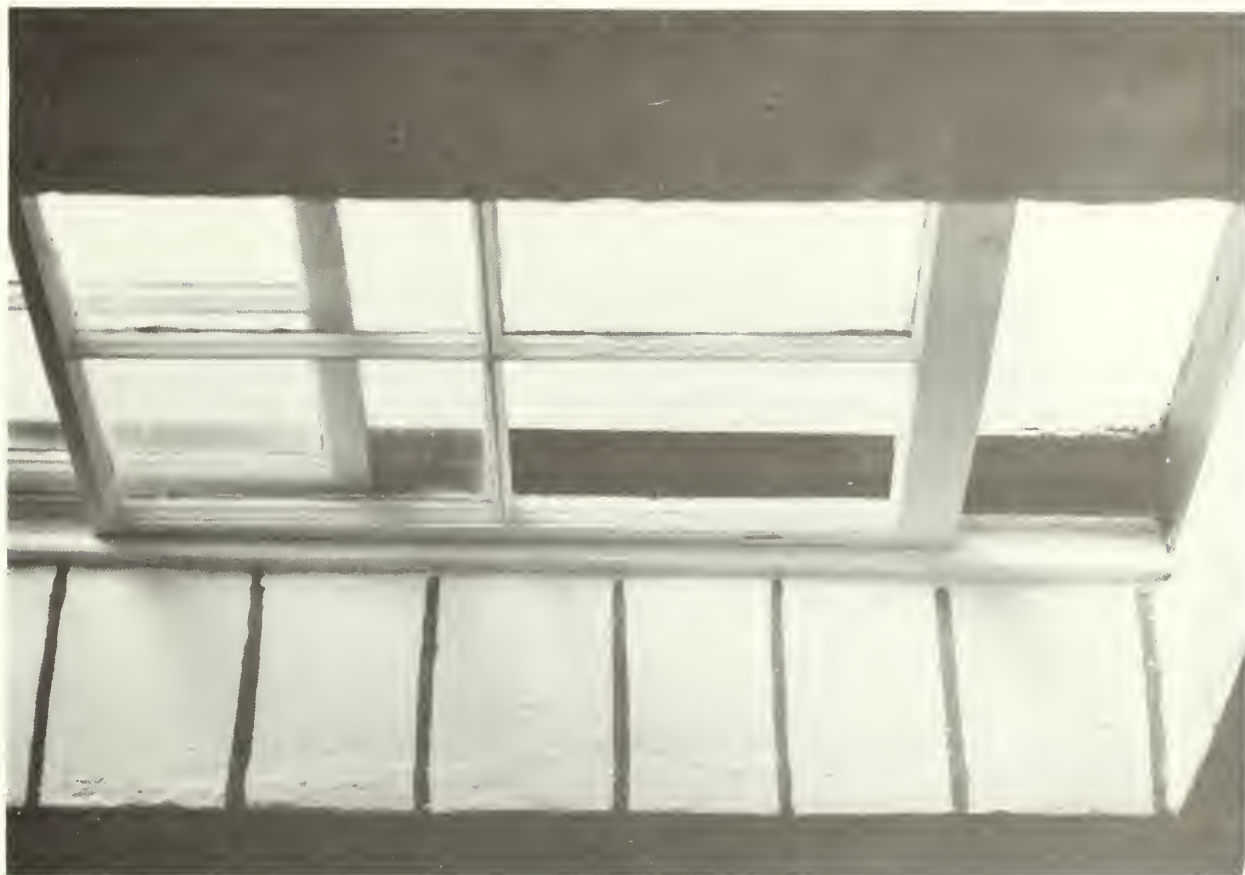
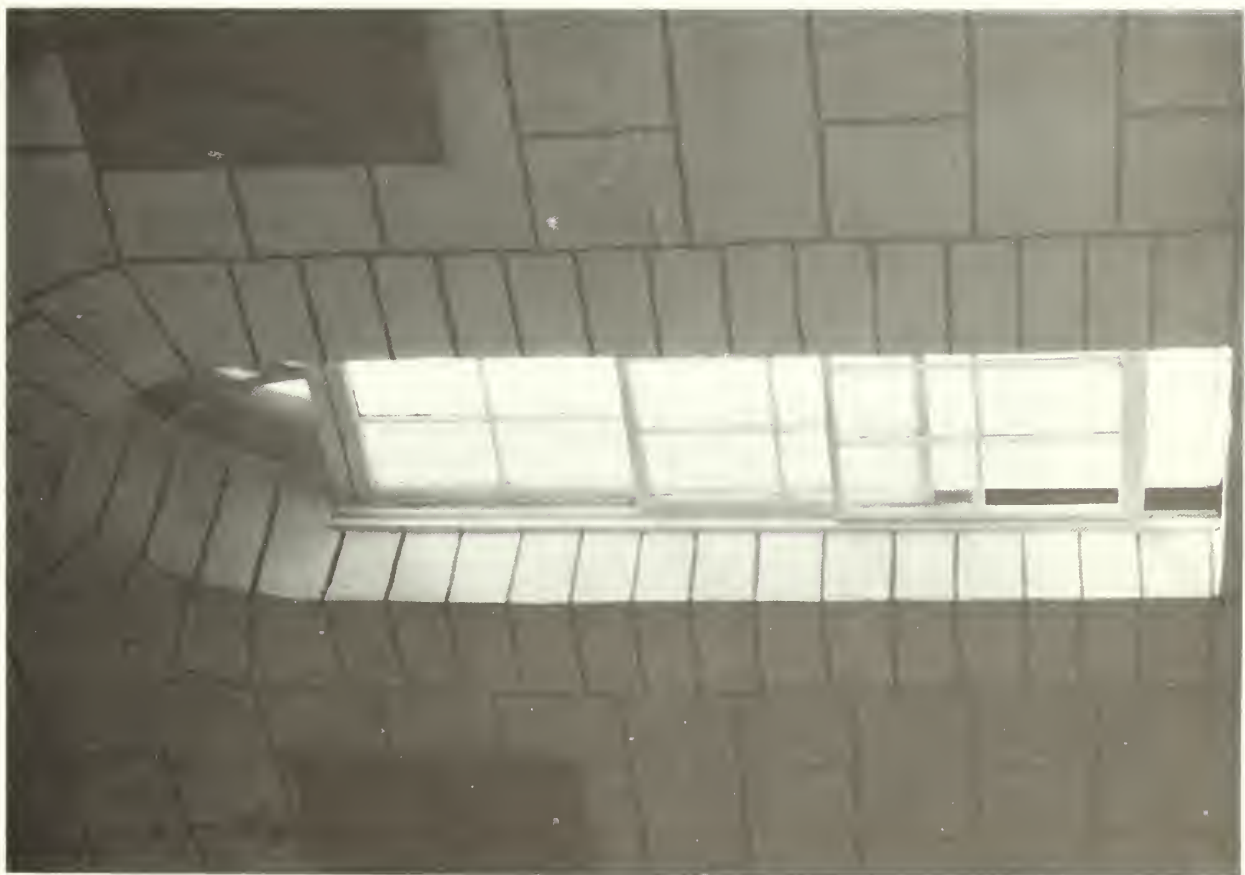
Illustrations A54 and A55.

Window details, 1888 nave. Only the lower sash units of these windows are operable. There is no hardware, nor does it appear that there ever was, so they must be propped open. Some glazing is missing, as illustrated here, or broken. Sash, sash guides, wood jambs and sills need refurbishing, and in some cases, elements need replacement. 6/84.
R.L.C.

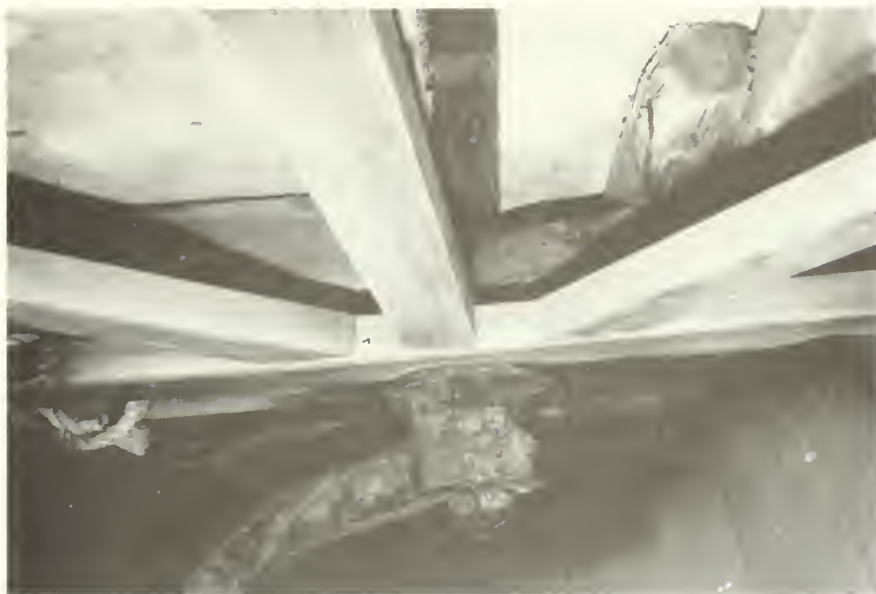
Illustration A72.

Detail showing cribbing installed in August, 1984 as a safeguard against failure of the deteriorated shafts and connections of the bell yoke. 8/84. P.C.C.

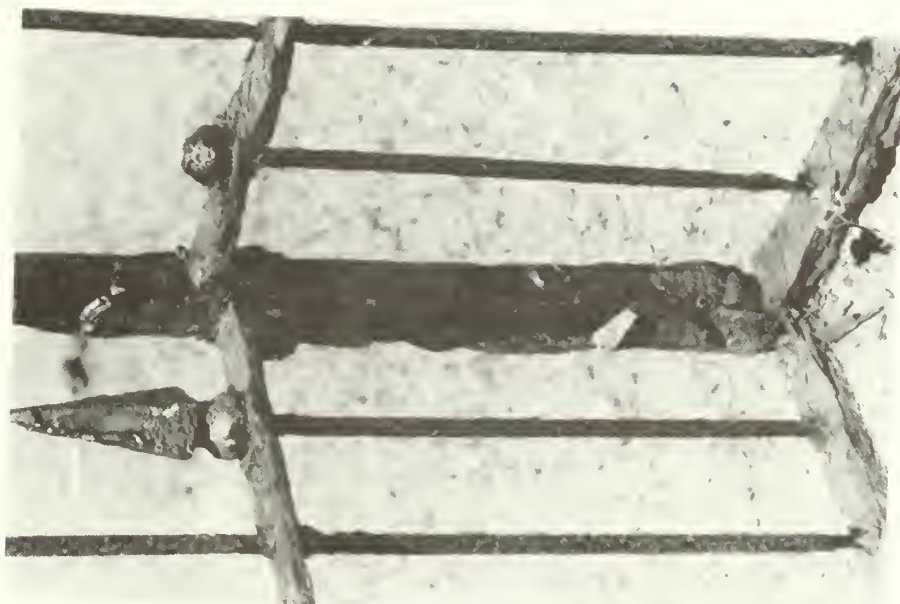
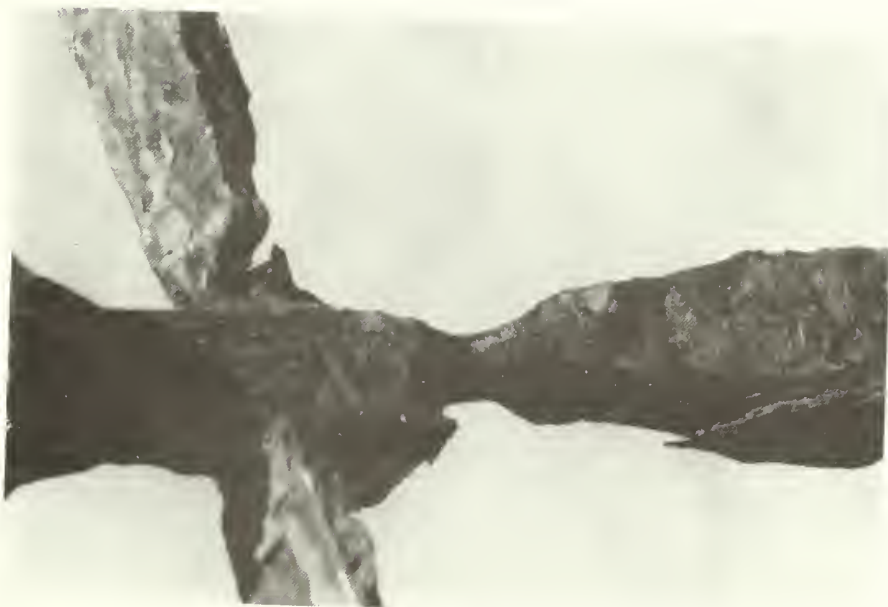
Illustrations A115 and A116.

Details of railing, Fr. Damien's grave, showing deterioration of metal. 6/84. R.L.C.

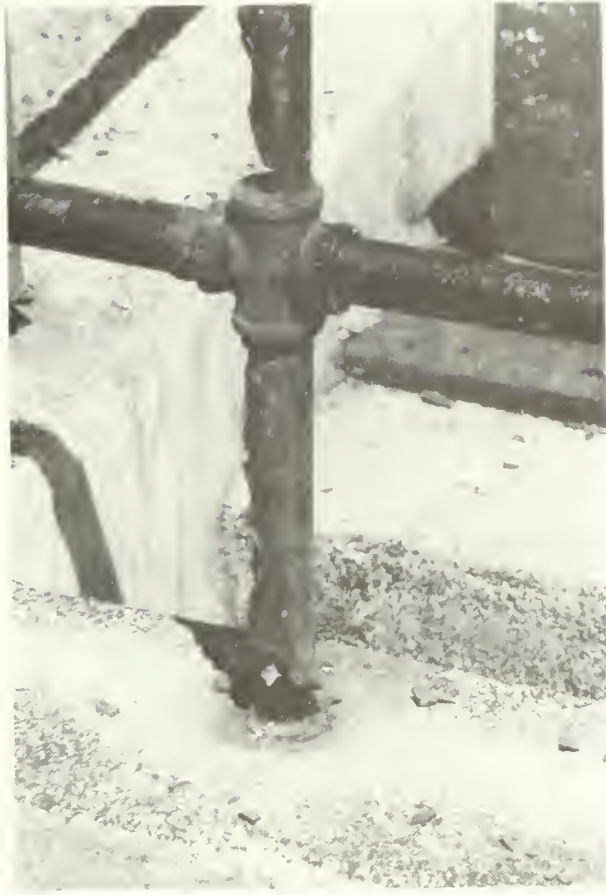
Illustration A124.

Detail of deteriorated pipe railing of Br. Dutton's grave. 6/84. R.L.C.
